# Manhole Inspection Summary

Manhole # S21A1\_002MH

Insp Date: **5/18/08 12:59 PM**

**Location** Address: **2229 hollins ferry rd**

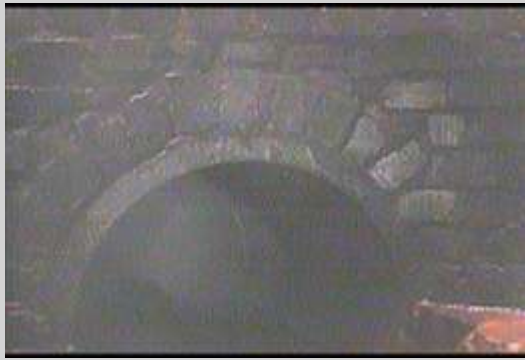
12 O'Clock Outflow

Pipe Height: **24** (in.) Rod and Bar (Angled)  
Pipe Material: **Clay** ☐ Pipe Lined  
Invert Depth: **18.48** (ft.) Flow Characteristics: **Fast**  
Deposits: ☒ None ☐ Mud ☐ Sludge ☐ Debris ☐ Grease  
Silt Depth: **0** (in.) Deposits Extent:  
Infiltration: **None** Pipe Seal Cond: **Sound**

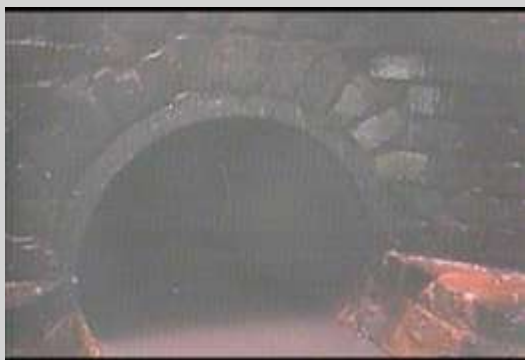
3 O'Clock Inflow

Pipe Height: **24** (in.) Rod and Bar (Angled)  
Pipe Material: **Clay** ☐ Pipe Lined  
Invert Depth: **18.39** (ft.) Flow Characteristics: **Fast**  
Deposits: ☒ None ☐ Mud ☐ Sludge ☐ Debris ☐ Grease  
Silt Depth: **0** (in.) Deposits Extent:  
Infiltration: **None** Pipe Seal Cond: **Sound**
